Strengthening and underpinning the foundations of the main building of the Ministry of Foreign Affairs of Finland

KARI AVELLANIN POSTER

**XIV European Conference on Soil Mechanics and Geotechnical Engineering,
24th-27th September 2007, Madrid, Spain**

K. Avellan & M. Nissinen

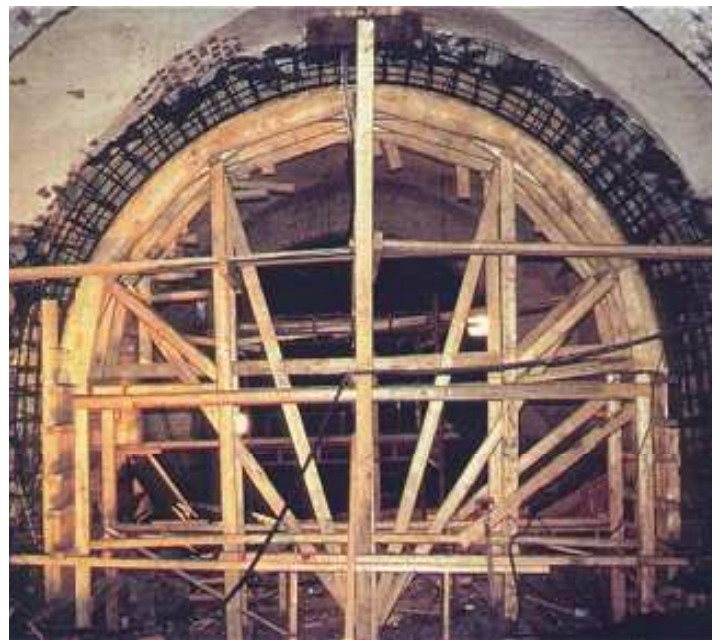
Photograph 2. Perpendicular wall. Temporary supports. Drilled steel piles. Reinforcement of concrete arch.

The substructure of the perpendicular wall was temporarily supported. Loads of the first floor were taken temporarily, partly by steel tension ties up to the old steel beams of the second floor, and partly on drilled steel piles (photograph 2). The permanent support of the substructure designed as a concrete arch, similar to the existing ones nearby, also acts to retain the earth pressures at rest.

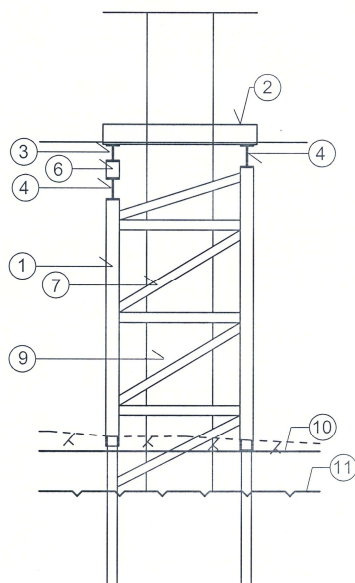
Figure 2. Middle wall. Drilled steel piles. Steel beams and jacking system. Bracing.

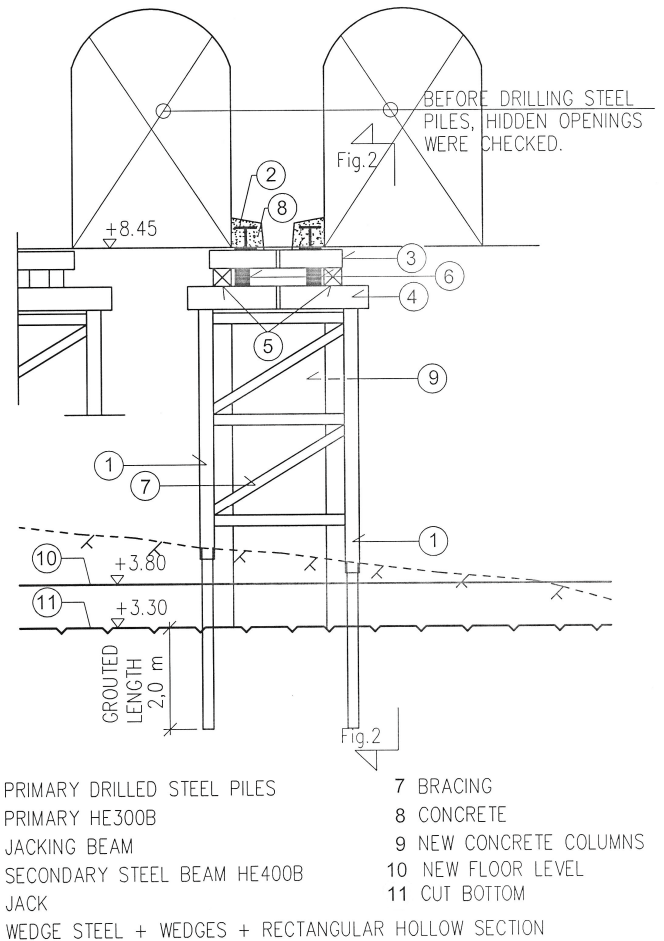
Loads of the middle wall were taken First on temporary structures and then on concrete structures as follows (figure 1-2):

- steel piles were drilled and cement grouted in the bedrock on both sides on the wall, because of the presence of stratified rock and because of blasting. The piles were designed separately as point bearing and as in-rock grouted piles.

- steel beams were installed through the brick wall
- wall loads were taken by jacking steel beams on piles. The jacking operation was controlled by levelling in order to find the right jacking forces. During the digging work drilled steel piles were braced by welding rolled steel angles between them, making trusses

Figure 1. Middle wall. Drilled steel piles. Steel beams and jacking system. Bracing.

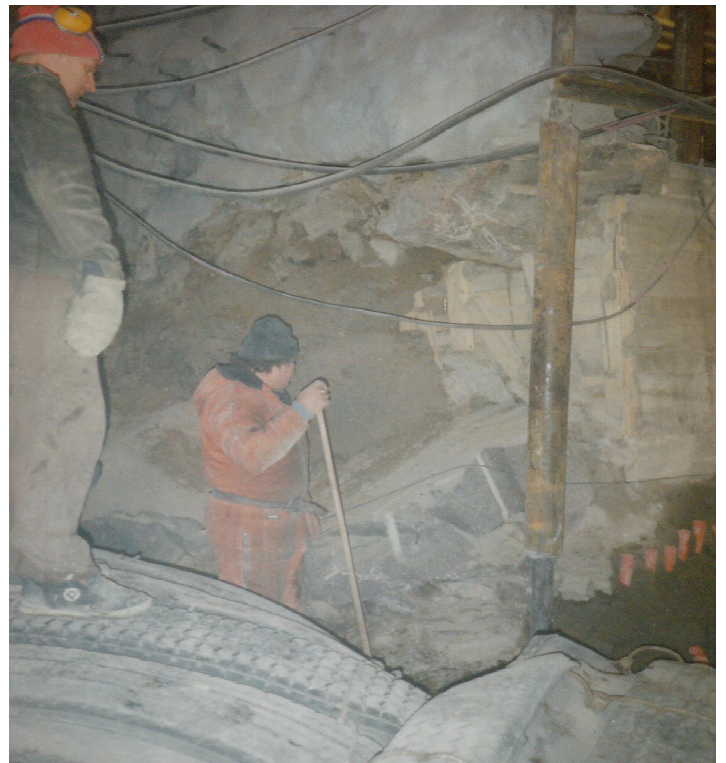
- rock blasting with explosives was done around the trusses. The minimum distance from piles to smooth blasted face was 0.5 m
- in close distance to the steel piles and under brick columns / brick wall, only old hand methods of loosening rock by using close spaced holes, wedges and hammer were normally accepted. In some cases the loosening of rock could be done by hydraulic wedge machine (Darda) (photograph 3).

Photograph 3. Middle wall. Drilled steel piles. Smooth blasted face. Close spaced holes ready for old hand method loosening rock with hammer and wedges.

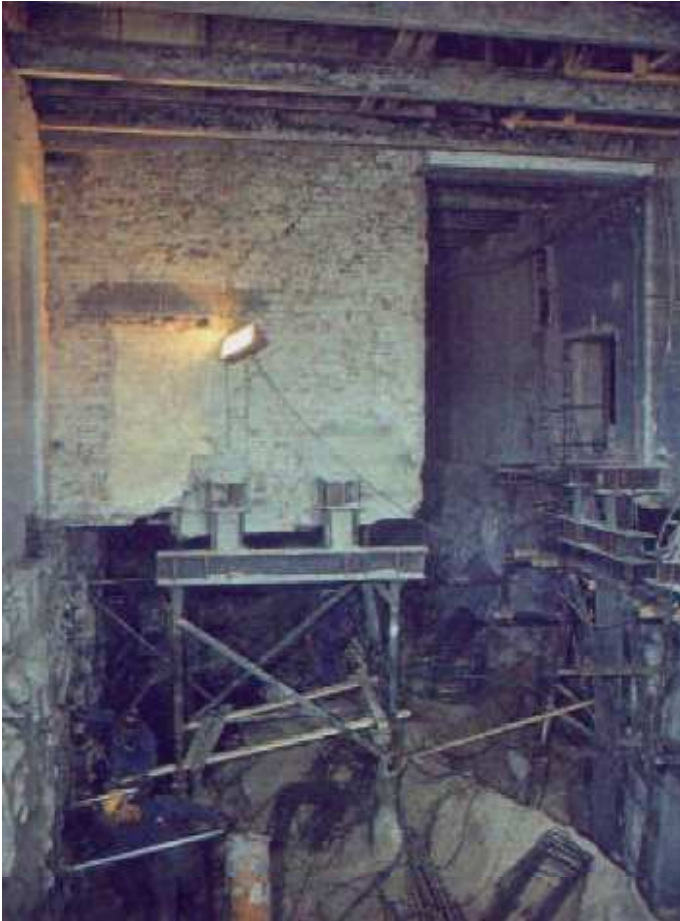
- form work and reinforcement were done inside the temporary steel structures and new columns were poured (photograph 4)

Photograph 4. On the right: middle wall. Center: reinforced concrete column and temporary steel supports, braced steel pile truss. Left: injection work (northern wall).

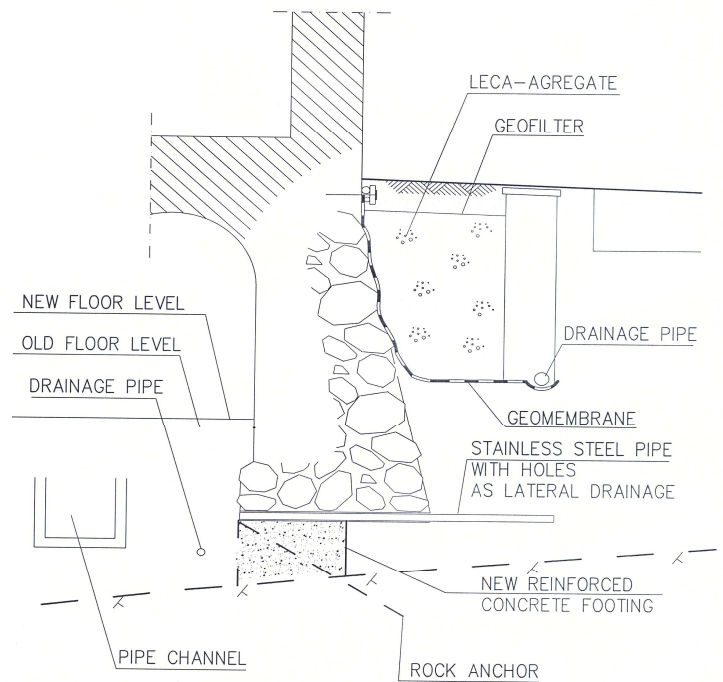
Nearby the southern wall a pipe channel was constructed to the level + 2.5 m. The old wall was not strong enough to retain the earth pressure at rest. To solve this retain problem some of the earth adjacent to the wall was substituted with Leca-aggregate, hence the pressure was minimized. The wall was also supported by using prestressed permanent rock and earth anchors (figure 3).

Figure 3. Southern wall. Soil pressure at rest minimized by using Leca-aggregate. Lateral drainage through wall. New footings and rock-anchors.

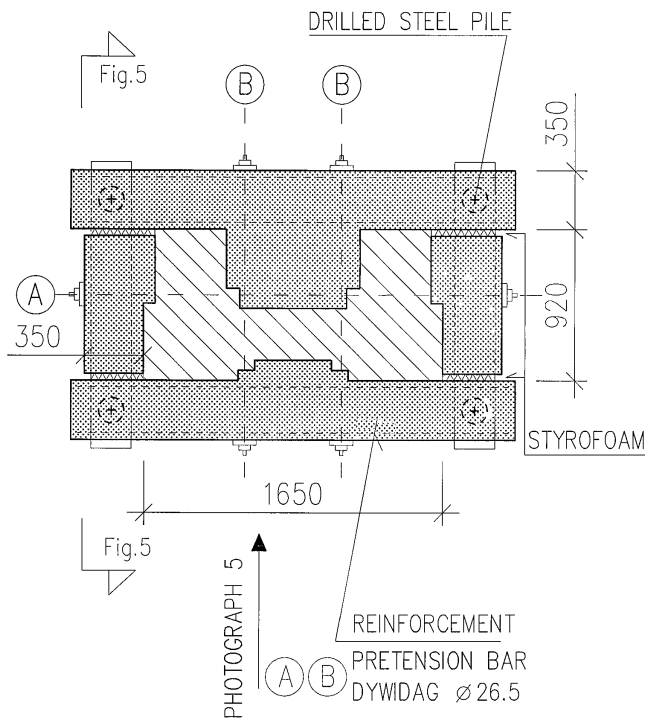
The loads of the brick made stair columns were temporary supported by drilled steel piles as in the case of the middle wall. The irregular brick column was covered in a mantel of concrete. In order to get enough friction force between the concrete and the brick column the mantel was stressed against the brick column by tension bars. The mantel was divided in four sections by Styrofoam joints to be sure that pretension on the concrete plate is against brick column (figure 4, photograph 5).

Figure 4. Eastern stair column. Structural stages. Pretensioned concrete mantel and drilled steel piles.

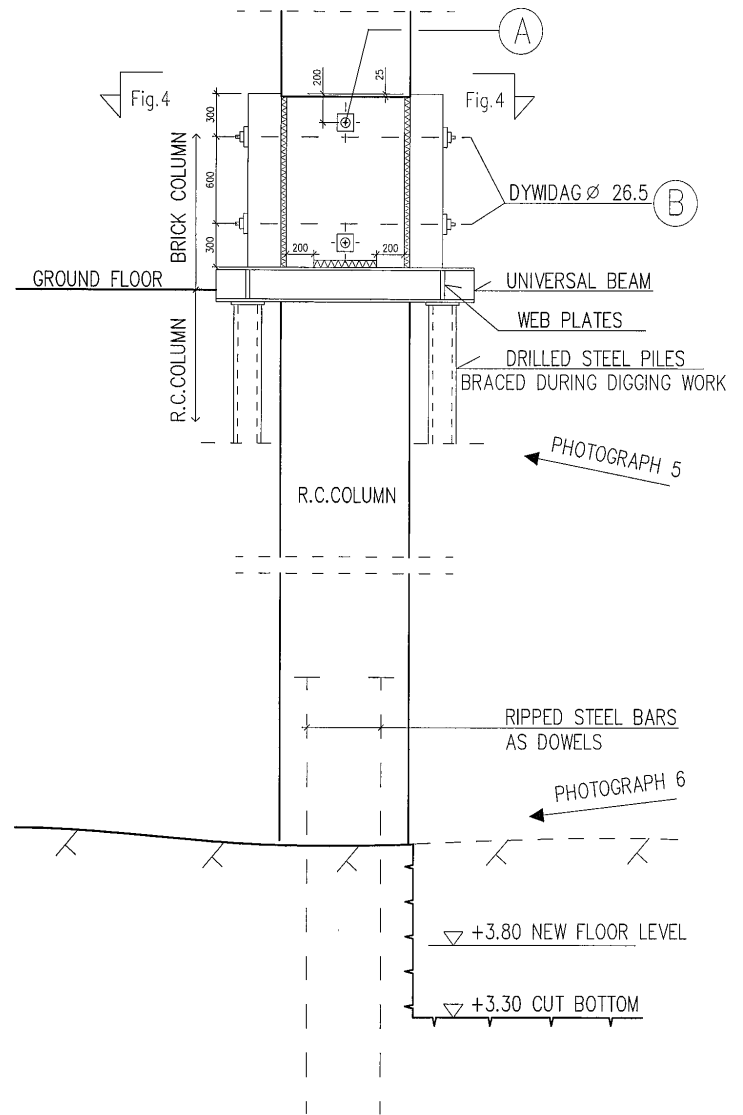
A concrete column was poured according to the measures of the brick column. To avoid blasting damages the whole column load was taken by vertical steel dowels between concrete and rock (figure 5, photograph 6).

Figure 5. Eastern stair column. Structural stages. Pretensioned concrete mantel and drilled steel piles. Reinforcement concrete column. Levels of rock and blasted rock.

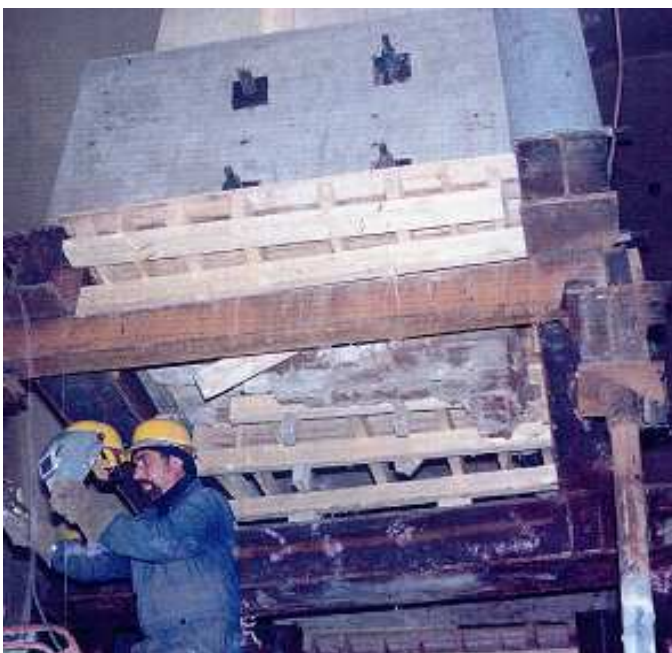
Photograph 5. Eastern stair column. Structural stages. Old brick column. Pretensioned concrete plates. Temporary steel supports.

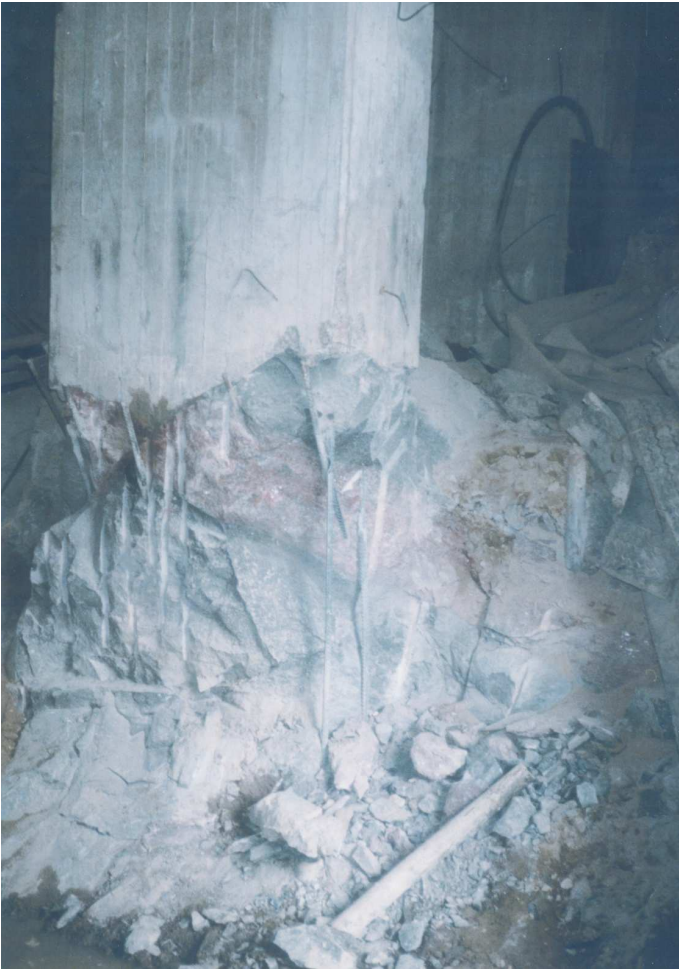
Photograph 6. Eastern stair column. Structural stages. Loosened, fissured rock. Dowels and hammer visible.
