Strengthening the foundations of St. John's Church in Tartu, Estonia

K. AVELLAN, KAREG Consulting Engineers, Helsinki, Finland

PROCEEDINGS OF THE FIFTEENTH INTERNATIONAL CONFERENCE ON SOIL MECHANICS AND GEOTECHNICAL ENGINEERING ISTANBUL / 27-31 AUGUST 2001

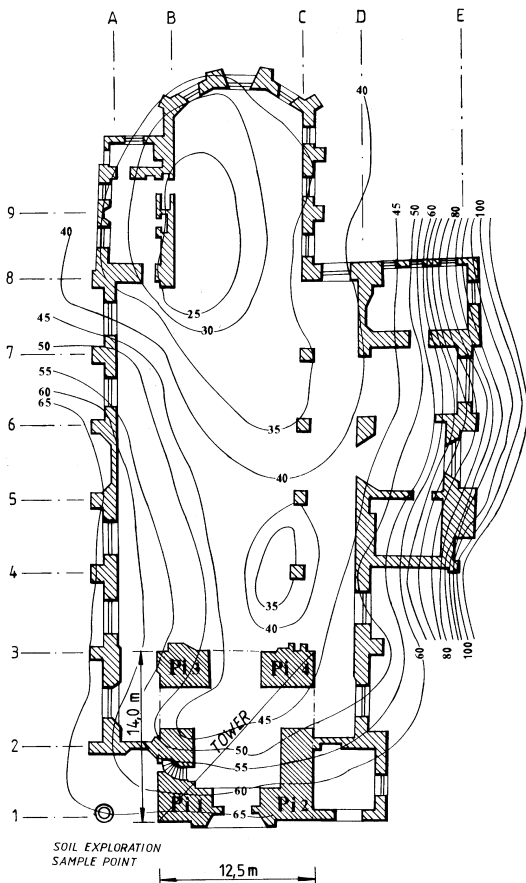
Figure 2. Settlement lines and coordinate lines

During recent decades, the building began to sink because of the lowering of the ground water. In the last few years before the strengthening work started the water level had dropped below

the level of the wooden rafts. As a result, the wood had begun to rot, thus accelerating the sinking process.

The settlement lines based on sinking measurement of the church between 1963-1987 are in Figure 2.
