UNBRACED PIPE TRENCH STIFF FISSURED CLAY LAYER ON SOFT CLAY

**Kari Christer Avellan, Helsinki
Finland**

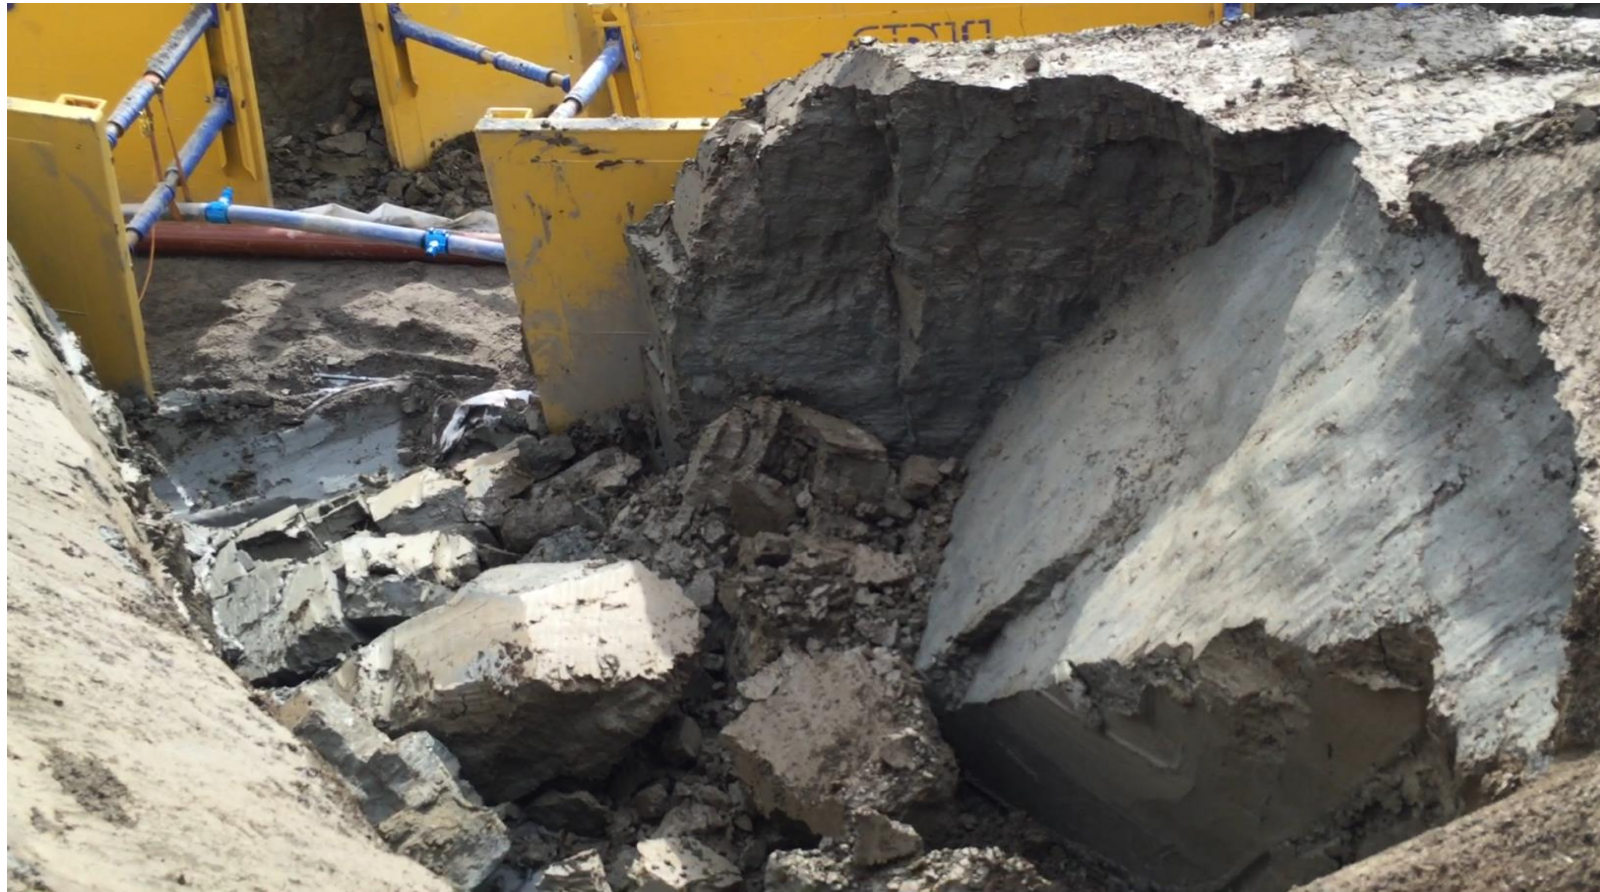
Case in southern Finland, crossing pipe trenches. Failure due to tension crack in stiff clay. Collapsed edge 4 m x 2,3 m (L x H).

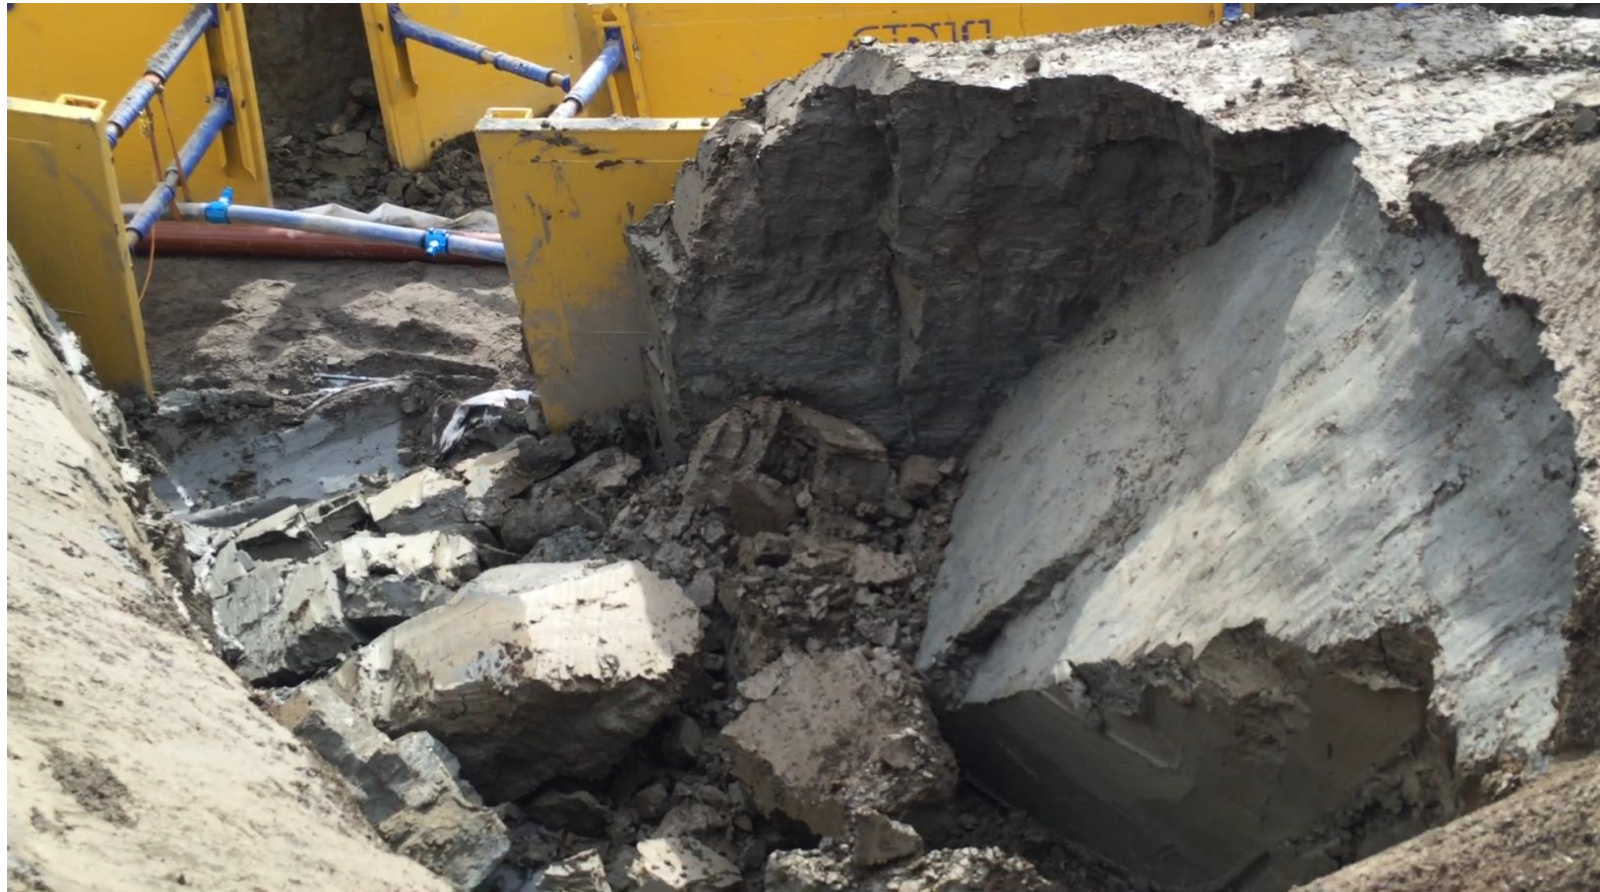
Case in southern Finland, crossing pipe trenches. Failure due to tension crack in stiff clay. Collapsed edge 4 m x 2,3 m (L x H).

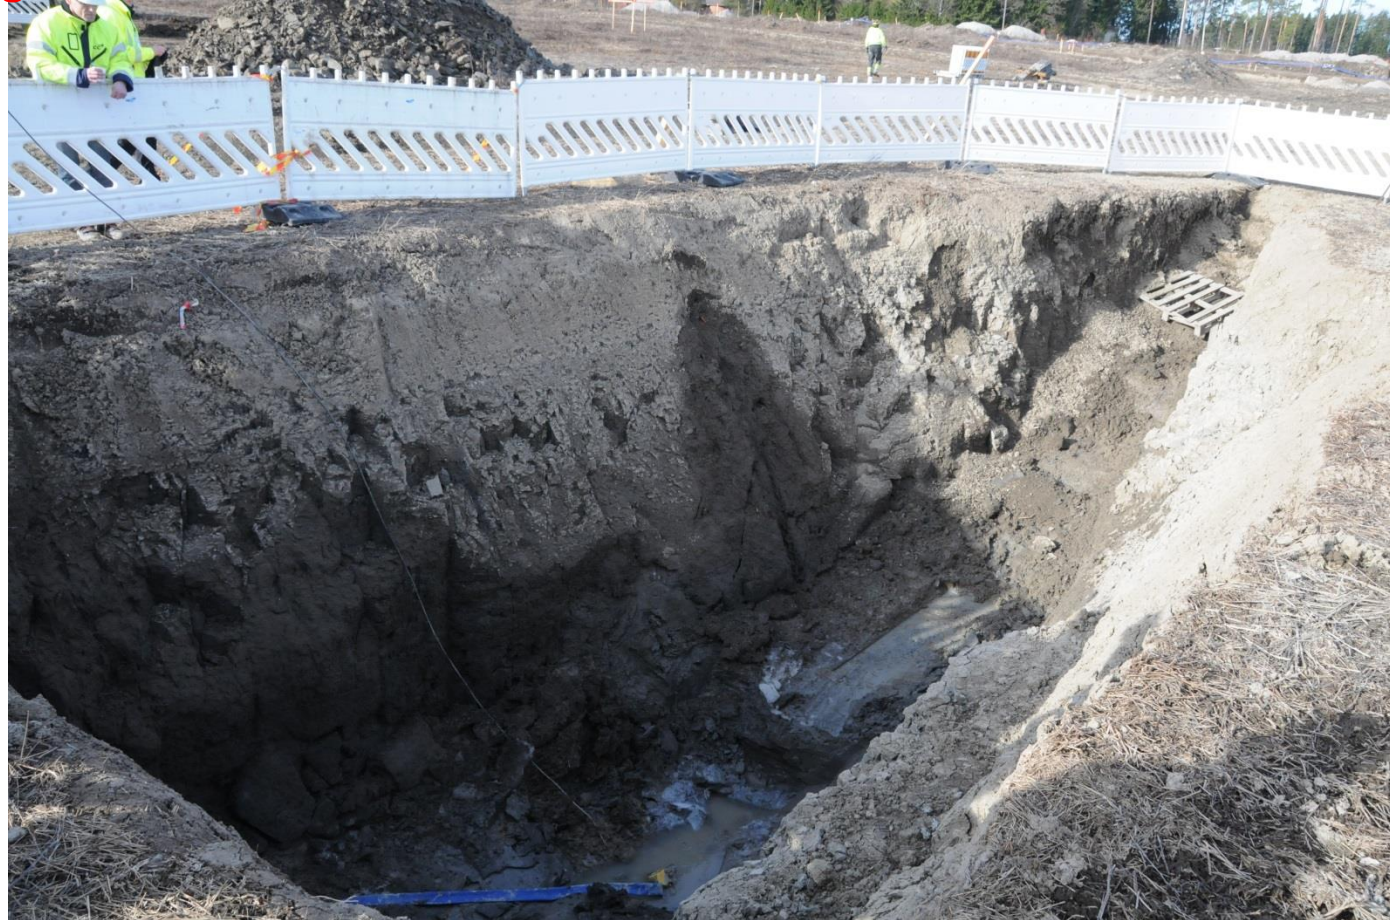
Figure 10.
Unbraced test
trench. Underlying
soft clay is flowed
towards the trench

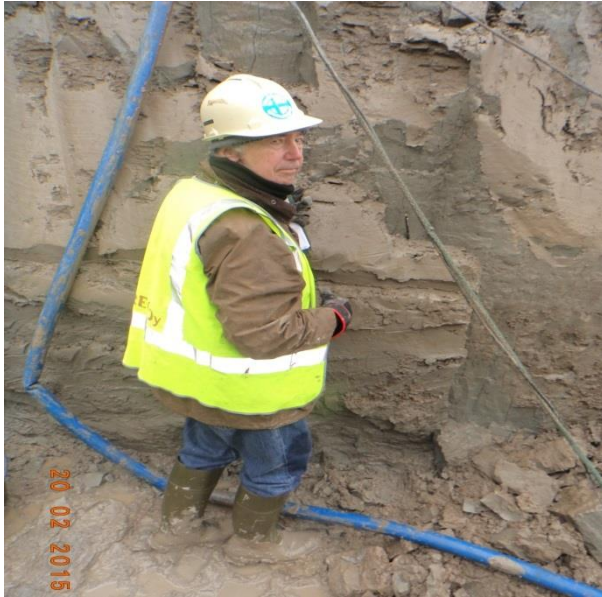
Figure 14. Test trench, depth of visible crack apr. 1,8m from surface.

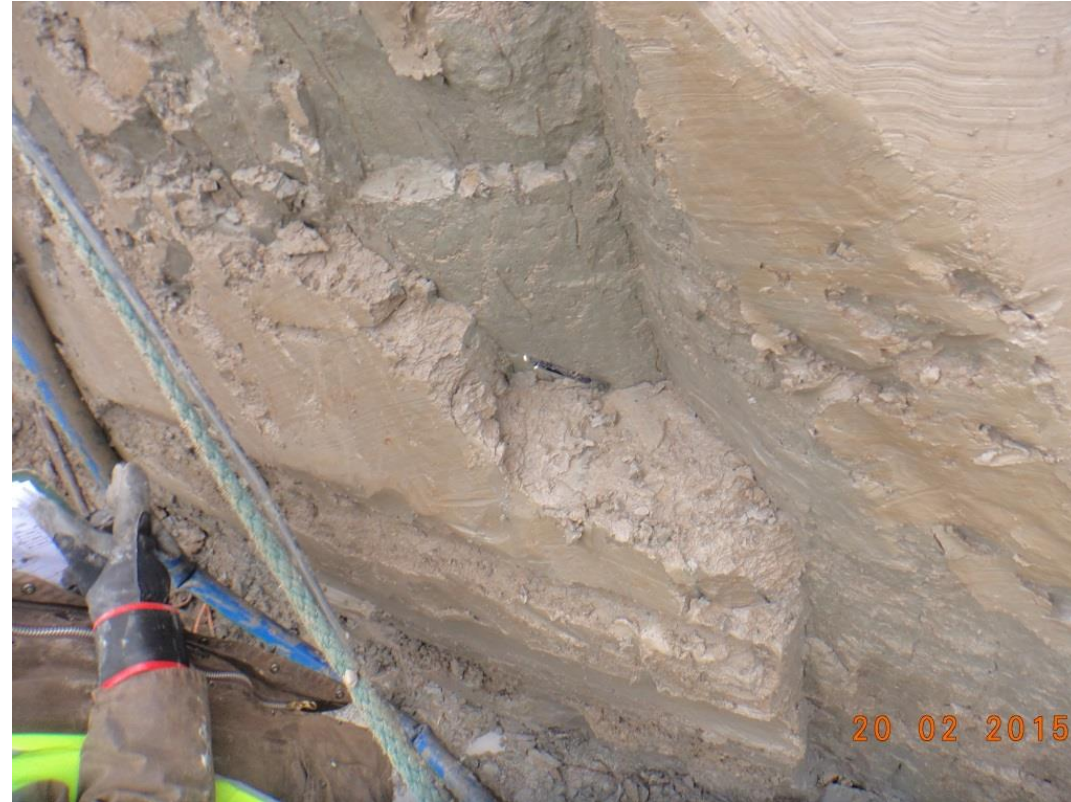
Figure 15. Detail picture of the crack.
