Strengthening the foundations of St. John's Church in Tartu, Estonia

K. AVELLAN, KAREG Consulting Engineers, Helsinki, Finland

PROCEEDINGS OF THE FIFTEENTH INTERNATIONAL CONFERENCE ON SOIL MECHANICS AND GEOTECHNICAL ENGINEERING ISTANBUL / 27-31 AUGUST 2001

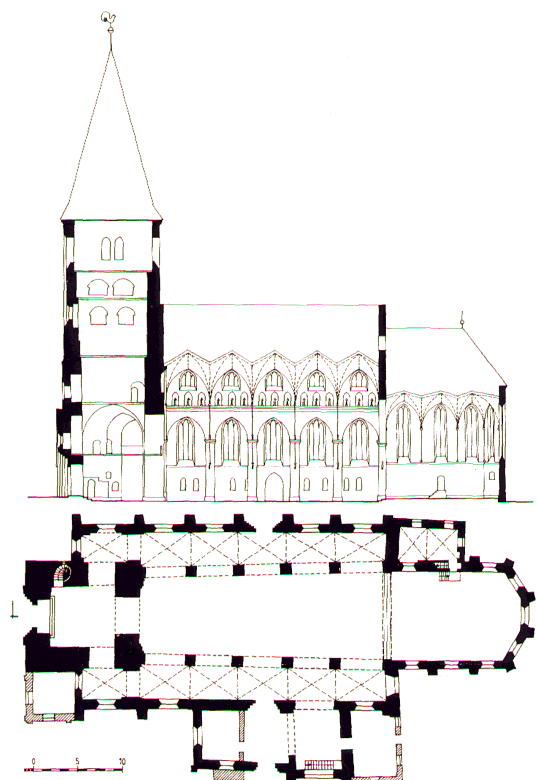
Figure 1. Plan and section of church

The existing foundations of the church rest on massive stones on wooden rafts. On the top layer these stones are joined together with mortar, but at the lower level joints are filled with sand.

During recent decades, the building began to sink because of the lowering of the ground water. In the last few years before the strengthening work started the water level had dropped below

the level of the wooden rafts. As a result, the wood had begun to rot, thus accelerating the sinking process.

Restoration work, on the church building, began with underpinning the foundations to end the continuing sinking process that would have caused the building serious damage in coming years.

The foundations of the building were underpinned by piling, jacked piles and spiral drilled piles. At the present state the building did not tolerate the vibrations of the driven pile.
